M1 Rifle sear/hammer/trigger lug engagement problems and remedies

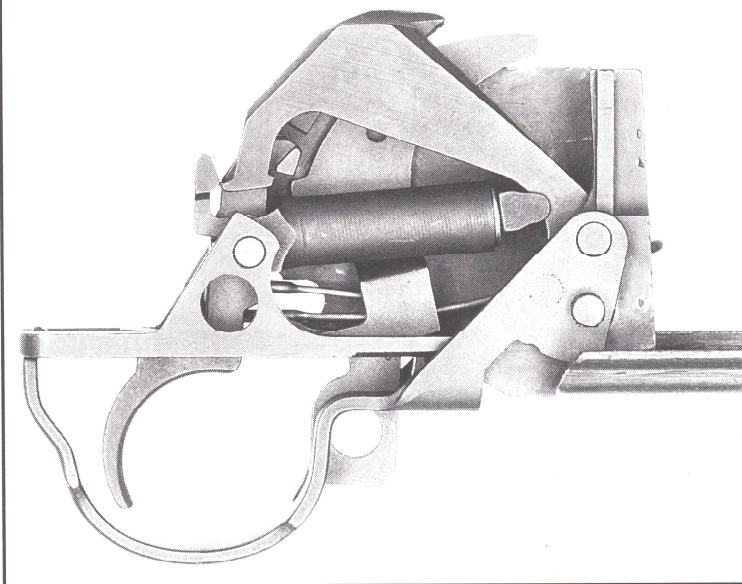
Although the failed hammer hand-off condition in this example was caused by shortened front hammer hooks only, failed hammer hand-off and limited front hammer hook/trigger lug engagement at the hand-off point can also occur as a result of trigger lug or sear alteration and/or accumulated sear, hammer hook, and trigger lug surface wear.

Figure 185- Shows a hammer with altered front hooks installed in an otherwise serviceable M1 trigger group. In this example, the front hammer hooks are too short to engage the trigger lugs at the point the sear releases the hammer to hand it off to the trigger. As the sear attempts hand-off, the front hammer hooks miss the trigger lugs and the hammer escapes. The result is that releasing the trigger also releases the hammer- one of the causes of uncontrolled fire.

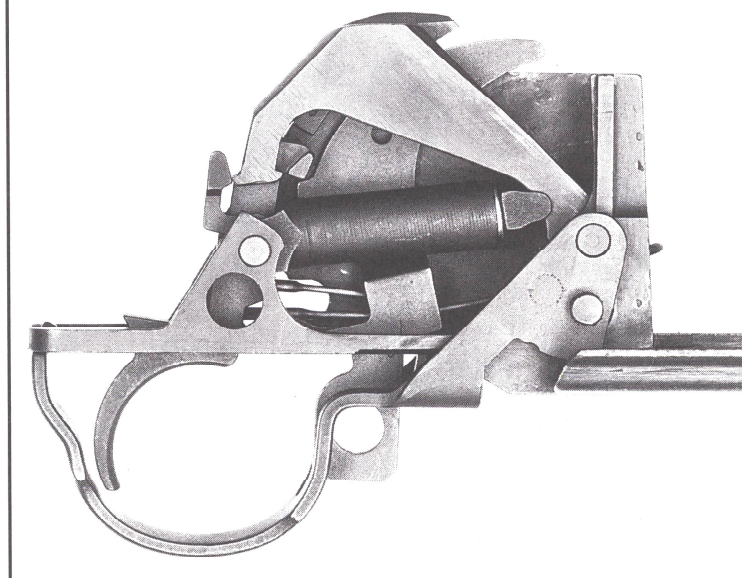
Although the failed sear engagement condition in this example was caused by short rear hammer hooks only, failed sear engagement, early hammer hand-off, and limited trigger lug engagement at the hand-off point can also occur as a result of sear or trigger lug alteration and/or accumulated sear, hammer hook, and trigger lug surface wear.

Figure 186- Shows a hammer with shortened rear hooks installed in an otherwise serviceable M1 trigger group. Here, the rear hooks are much too short for capture by the sear. As a result, the hammer doesn't disconnect or cock and can only follow the bolt forward. In cases where sear and/or rear hammer hook surface condition permits only partial sear (disconnect) engagement, hammer hand-off (if it occurs at all) will be early and trigger lug engagement minimal- another possible cause of uncontrolled fire.
