**M1 trigger pull problems and remedies**

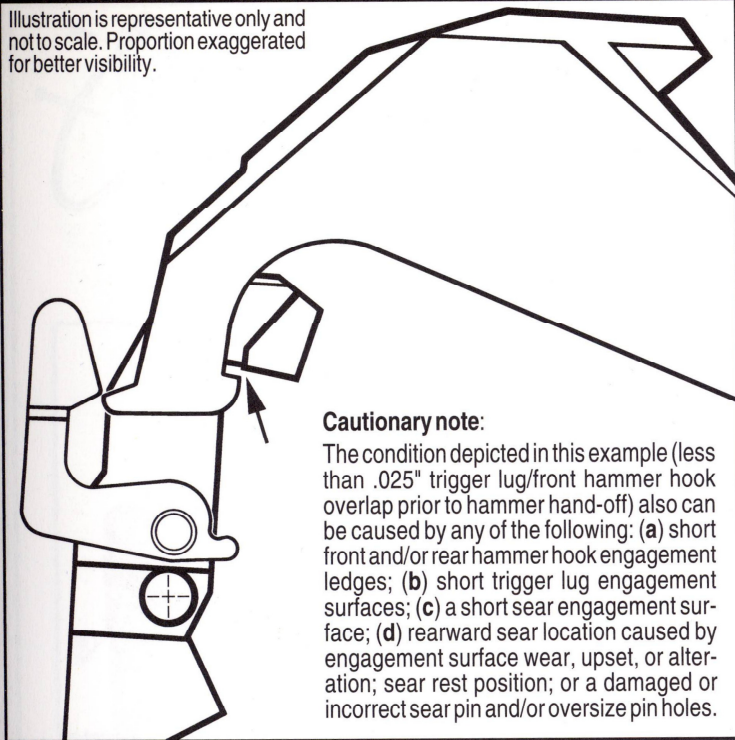
Illustration is representative only and not to scale. Proportion exaggerated for better visibility.

The condition depicted in this example (less than .025" trigger lug/front hammer hook overlap prior to hammer hand-off) also can be caused by any of the following: (a) short front and/or rear hammer hook engagement ledges; (b) short trigger lug engagement surfaces; (c) a short sear engagement surface; (d) rearward sear location caused by engagement surface wear, upset, or alteration; sear rest position; or a damaged or incorrect sear pin and/or oversize pin holes.

**Figure 187-** In the above example, rearward sear position causes hammer hand-off before the trigger lugs overtravel the front hammer hooks as far as they should. Rearward sear position acts to lighten trigger pull by reducing second stage trigger spring pressure and by providing greater sear breakaway clearance- but also increases the potential for sear failure to engage the hammer and for uncontrolled hammer release.

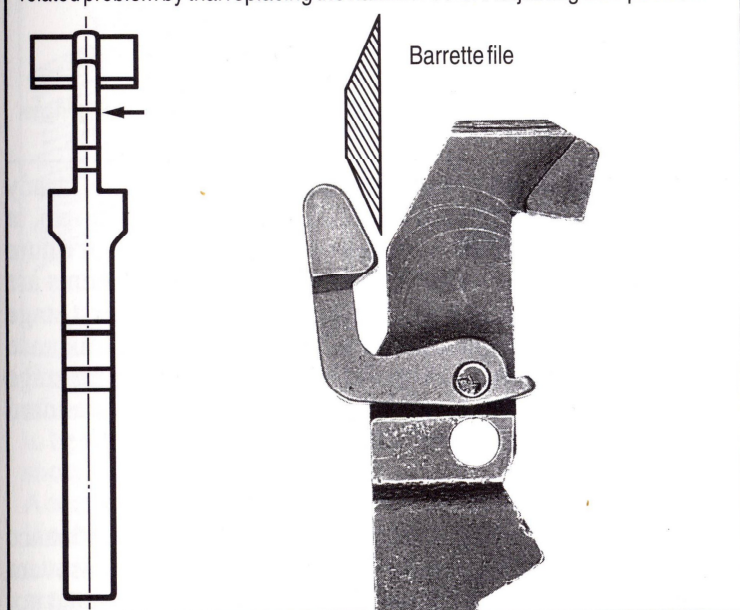
**Figure 188-** Arrow indicates location of the sear stop surface on the back of an M1/M14 trigger that is adjusted to move the sear forward. Use a 4" barrette file and strip of #240 sandcloth to remove just enough material from the back of the trigger to: (a) return sear/rear hammer hook engagement and trigger lug/front hammer hook engagement at the hand-off point to within normal range or (b) return trigger pull to within specification when the hammer and hammer spring are both serviceable.

Sear position is adjusted forward in *tuned* and match conditioned M1 trigger groups for 3 reasons: (1) trigger pull is too light; (2) sear/rear hammer hook ledge engagement is minimal; or (3) trigger lug/front hammer hook engagement is minimal at the hammer hand-off point. See warning, at right. Rule out a hammer related problem by trial replacing the hammer before adjusting sear position.

1. Replace worn, altered, or damaged trigger group components with within specification U.S.G.I. parts.
2. Limit fitting of new parts to deburring and light bearing surface stoning to remove the phosphate coating and minimize drag: don't stone through the case.
3. Adjust the trigger sear stop surface to move the sear forward and increase hammer hook engagement as needed.
